Engineering Investigation of Ignition Failure Rate of TAU-15/B Infrared Target Flares

by Russell A. Bunn, Capt, USAF

APGC Technical Documentary Report No. APGC-TDR-63-27

MAY 1963 • APGC Project No. 7826W28

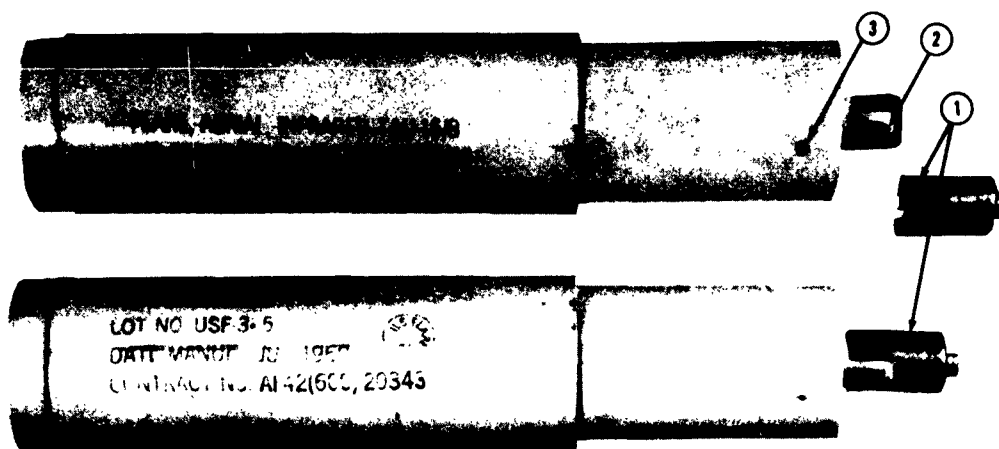
BAYONET CONNECTORS. Difficulties were experienced with the alignment projections on the flare bayonet connectors (Item 2, Fig. 2) during both the ground and airborne tests. The projections were too small and too soft and were easily damaged during insertion of the flares in the flare holders. As a result, when the projections were damaged, there was no physical way of determining whether the flare electrical contact points were positively aligned with the points in the flare-holder sockets. Consequently, ignition could not be assured. Several misfires in the altitude chamber were attributed to this condition. For test purposes in the chamber the problem was rectified by repositioning the flares which would not ignite and attempting a second or third ignition. Obviously this procedure could not be used during the airborne tests and only flares providing reasonable assurance of proper alignment were flown. Use of strong metal alignment pins of sufficient length should prevent similar difficulties with future similar flares.

ELECTRICAL SHUNTING CAPS. Three flares of Lot 3-5 were not equipped with electrical shunting caps (Item 1, Fig. 2) when they were unpacked from their individual cartons. The caps were not found loose in the cartons and obviously had not been installed when the flares were packaged at the factory.

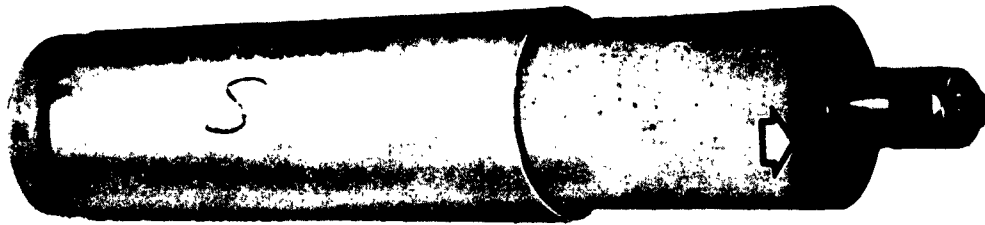
LEAKING WAX. Of 667 flares used during this test, 142 (approximately 21%) were characterized by the presence of various amounts of a clear, sticky substance on the forward portions of the cases. Samples of the substance were collected, chemically analyzed, and determined to be wax. KEL-F-40X wax is a constituent of the main illuminant. Examination of the data revealed that flares thus characterized did not ignite or burn any differently than flares without wax deposits. However, the presence of the wax was troublesome. Frequently, the wax had accumulated under and around the shunting caps, requiring the use of pliers to remove the caps. At other times one or both electrical contacts of the flares were covered with the wax. Flares in this condition were experimentally inserted in the flare holders to determine whether it was necessary to clean the contacts in order to obtain ignition. Invariably the presence of the wax on the contacts prevented ignition. Careful scraping was then required to remove the wax from the electrical contacts. In addition, the presence of the wax made handling of the flares unpleasant.

Fig. 7 shows evidence of leaking wax. In the flare shown the wax appeared to be seeping from the space between the phenolic base plug

Fig. 7: TAU-15/B Flare Showing Wax Deposits on Phenolic Base Plug and Case of Flare.

and the flare case. Note that the wax has deteriorated the paint. Most frequently the wax was found to be leaking from and around the hollow locking pin in the phenolic base plug of the flare. Fig. 8 shows two flare cartons which had contained flares from which wax had leaked and caused the stains shown.

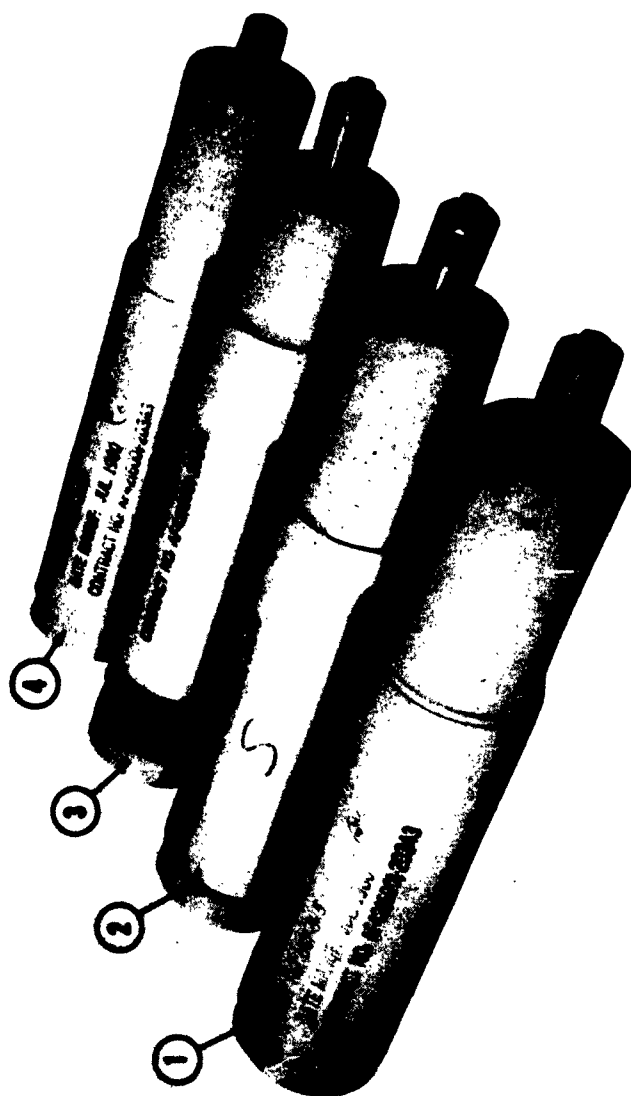
ASSEMBLY AND FABRICATION OF OUTER JACKET. The outer metal jackets on three flares from Lot 3-5 were improperly positioned (Fig. 9). It can be seen in the figure that the misalignment on two of the flares occurred after the flares had been painted. When the flares were unpacked, the glue used to hold the metal jackets had dried and they were firmly fixed in position. It appears probable that the glue had not yet set when the flares were packaged at the factory and that the outer jackets slipped out of position when the flares were inserted in the packing cartons. One jacket (Item 3, Fig. 9) had slipped so far forward that the flare could not be inserted in the flare holders used in the chamber. That flare was not tested. The discrepancy would not have prevented use of the flare in a flare holder of the type utilized on the TDU-6/B target but would have prevented its use on targets such as the TDU-9/B. The other two flares (Items 1 and 2, Fig. 9) did not burn properly in the altitude chamber; however, in neither case was the poor performance attributable to the jackets.

Fig. 9: TAU-15/B Flares Showing Improper Positioning of Outer Jackets: (1) Flare with Jacket Positioned Too Far Aft, (2) and (3) Flares with Jackets Positioned Too Far Forward, (4) Flare with Properly Positioned Jacket Shown for Comparison.

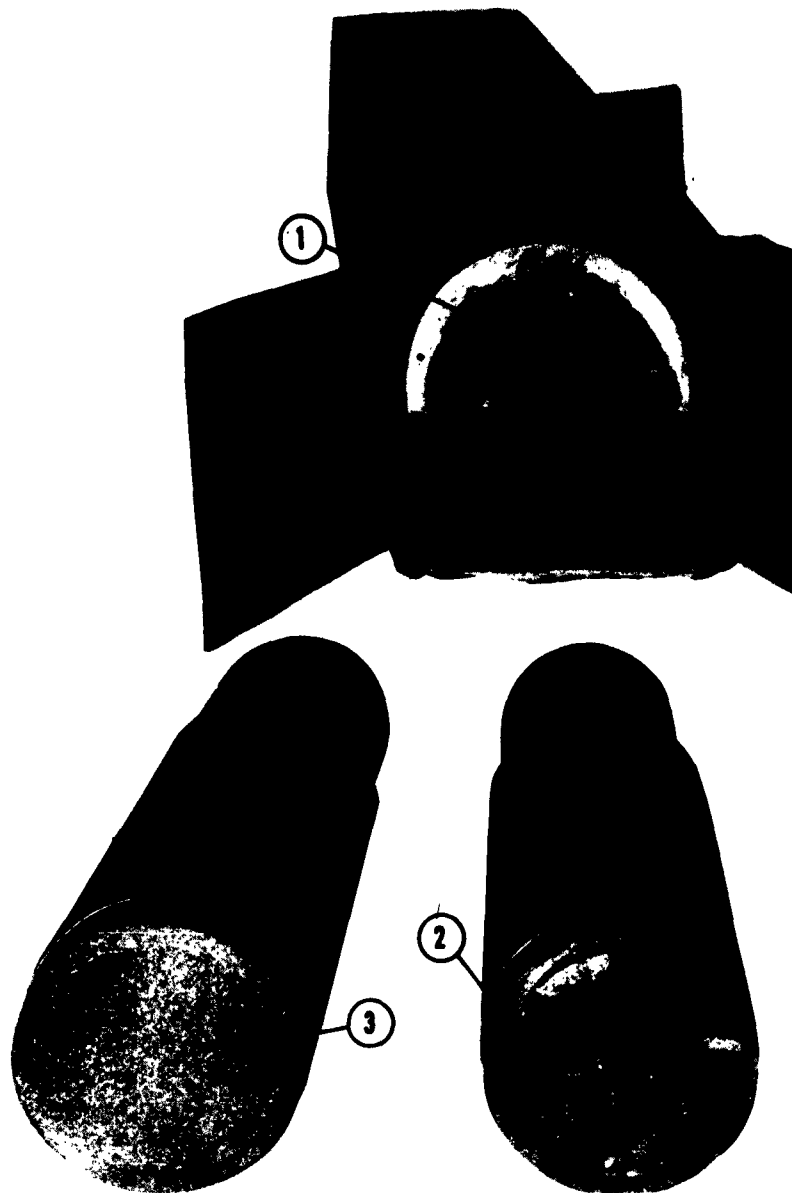
CLOSURE PLUG DEFORMATION. The potting compound used on the flare closure plugs was usually found to be hard and smooth; however, the closure plug of one flare from Lot 3-5 (Item 1, Fig. 11) had been badly deformed by contact with the carton in which the flare had been packed. The closure plug of another flare from the same lot (Item 2, Fig. 11) was also deformed and so soft that it could be marked by the thumbnail. Both of these flares were tested in the altitude chamber at simulated 35,000-ft altitude, with one having been cold soaked prior to having been placed in the chamber. The flare that had not been cold soaked burned normally, but the closure plug of the other flare separated only partially from the flare body at ignition, resulting in an abnormal plume during flare burning.

Fig. 11: Flares from Lot 3-5 Showing Condition of Closure Plugs: (1) Closure Plug Deformed by Contact with Packing Carton, (2) Soft Closure Plug (Marked by Thumbnail), (3) Closure Plug of Normal Smoothness and Hardness.

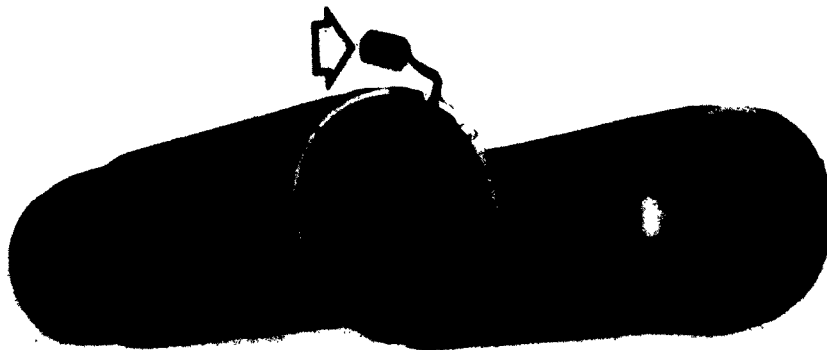
ILLUMINATION FAILURES. In 45 of the flares tested in the altitude chamber and during flight, the first fire composition and main illuminant failed to ignite after successful firing of the squibs. (See Fig. 12.) Thirty-one of such flares were from Lot 3-1. The data show that this characteristic is dependent on altitude and pressure as flares tested at sea-level conditions (other than two from Lot 3-1) did not exhibit this poor performance. Generally, these failures were instantaneous at squib firing; however, examination of Appendix I shows that seven flares sputtered momentarily before failing to burn after the squibs had fired and blown off the closure plugs. These instances raise even more doubt about the possible airborne performance of those flares already mentioned under "Illumination Delays."

Fig. 12: Typical Flares in which Squibs Fired and Blew Closure Plugs Off but Did Not Ignite First Fire Composition or Main Illuminant. (Arrows point to fired squibs.)

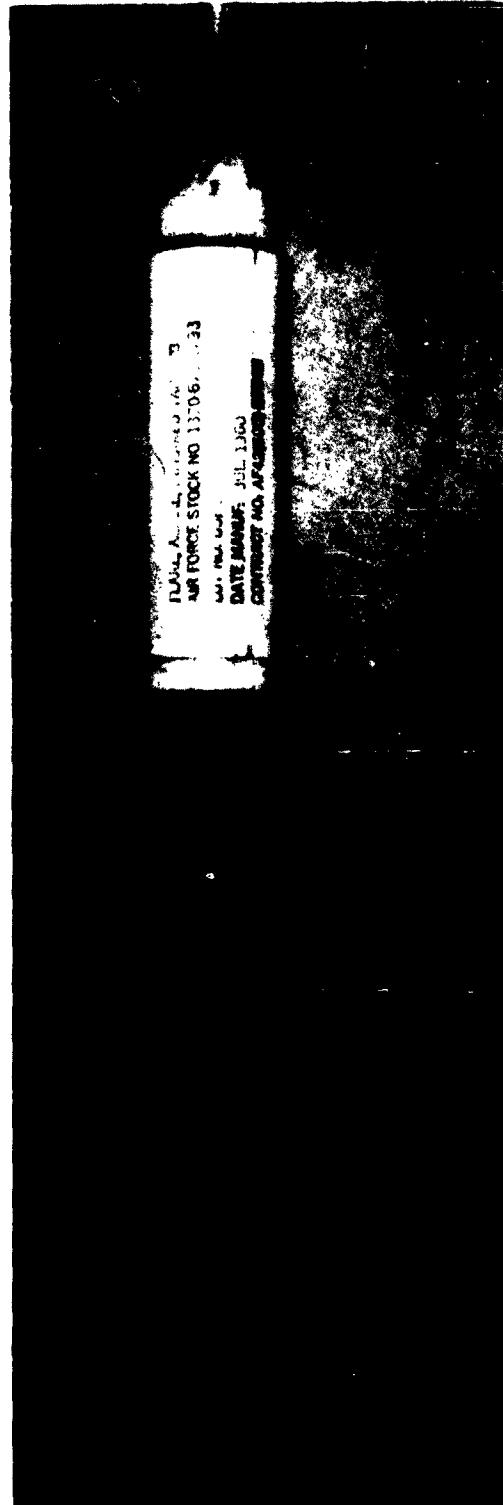
It also caused failures typified in Fig. 13. Thirty-six cold-soaked flares (22 of which were from Lot 3-10) literally exploded at squib firing. The explosions were of different intensities and character. (See Appendix I.) Sometimes only part of the illuminant blew out of the case and burned on the chamber floor while the remaining illuminant burned in the flare case. At other times all the illuminant blew out and burned on the chamber floor. Several times the cylinder of illuminant blew across the chamber and imbedded itself in the chamber wall, setting fire to the chamber wall insulation. As indicated in Fig. 13, the first fire composition and main illuminant sometimes exploded from the cases and did not burn at all. All failures during this test occurred simultaneously with squib firing and no flares exploded after burning for a short period as did some listed in Appendix IV.

The explosions were always very forceful and generally disrupted testing procedures by damaging the test setup in the altitude chamber. Spring-loaded contact points in the flare-holder sockets were often broken off by the shock. The base plates of two flare holders (Fig. 4) were bent beyond further use. The shock sometimes broke the welds holding the racks in an upright position and knocked the racks over. Illuminant burning on the chamber floor burned the ignition wiring and delayed testing while repairs were made.

The exact cause of the explosions was not determined. However, it is believed that uneven contraction of the flare cases and illuminant during cold soak provided space for the expanding gases created by squib firing and subsequent burning of the loose ignition composition to travel to the base of the flare before the closure plugs separated from the flare body. Thus the illuminant was forced out of the cases when the plugs blew off. In one instance the main illuminant did not blow out of a cold-soaked flare after squib ignition and separation of the closure plug from the flare case (Fig. 14). As shown in the figure there was obvious contraction of the main illuminant, thus supporting the hypothesis indicated above. As this flare warmed at room temperature, no noticeable expansion of the illuminant occurred during a 2- to 3-hour period.

Fig. 13: Typical Empty Flare Case and Cylinder of First Fire Composition and Main Illuminant which Was Blown Onto Floor of Altitude Chamber when Squib Fired.
